## Service Manual

ULT50-AM

# Exploded Parts Diagram

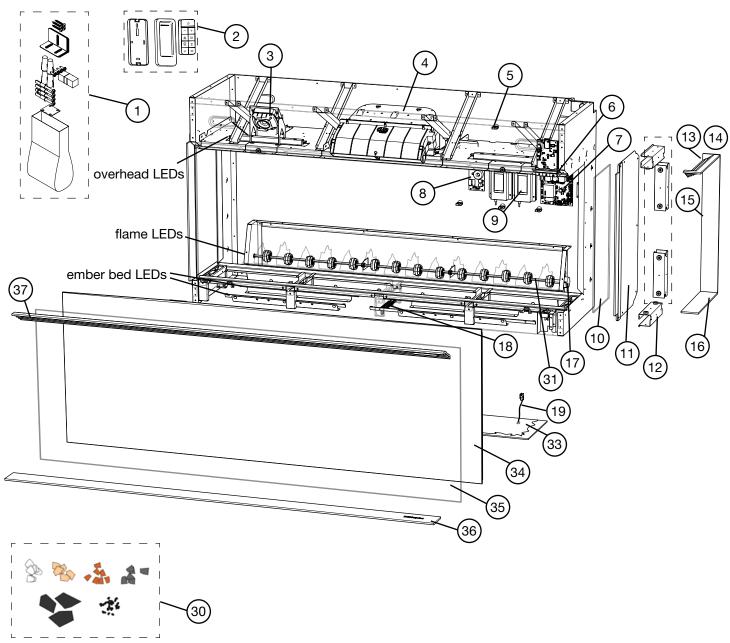
Hardware kit	500003777
Remote control	500003384
Speaker	500003391
Heater Assembly	500003383
Temperature sensor	X-3001560600RP
On-board controls	500003386
Main control board	500003385
Power board	500003869
Power supply 5 A	X-2100250500RP
Side glass (1)	500003641
Side panel (1)	500003773
Side bracket set	500003862
Side trim top - left	500003764
Side trim top - right	
Side trim rear	500003733
Side trim bottom	500003732
	Remote control Speaker Heater Assembly Temperature sensor On-board controls Main control board Power board Power supply 5 A Side glass (1) Side panel (1) Side bracket set Side trim top - left Side trim top - right Side trim rear

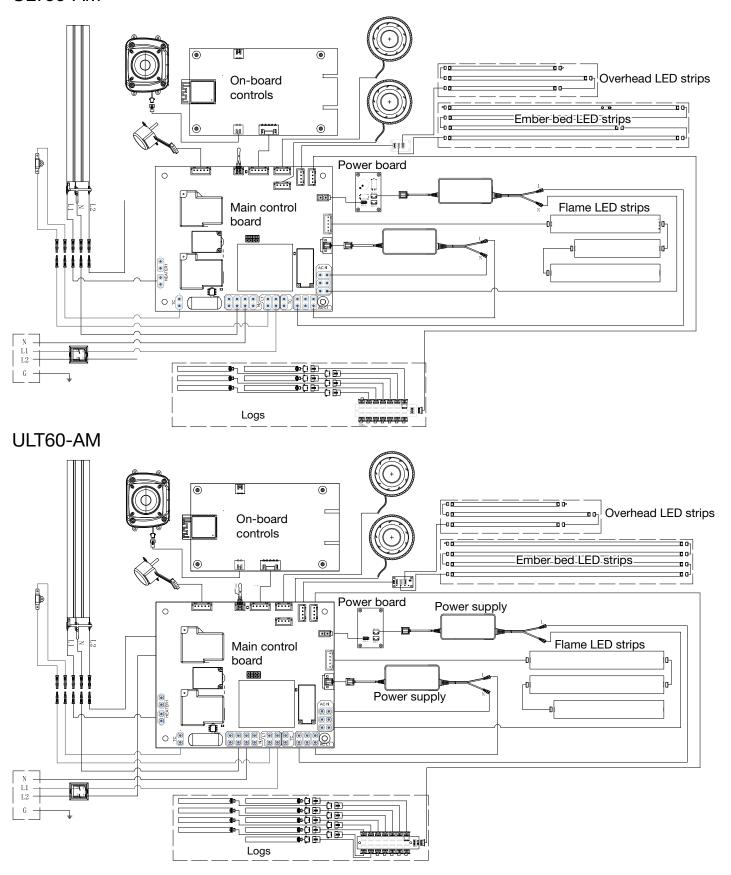
#### ULT50-AM

# Wiring Diagrams - North America

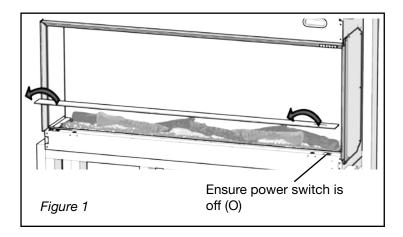
### Preparing the firebox for service in upper housing

Heater assembly, on-board controls, overhead LEDs, and speaker are located in the top of the fireplace. The front glass needs to be removed to access these components.

- **WARNING:**If the firebox was operating prior to servicing, allow at least 10 minutes for the heating elements to cool off to avoid accidental burning of skin.
- **WARNING:** Disconnect power before attempting any maintenance to reduce the risk of electric shock or injury to persons.
- 1. Turn off the power to the fireplace before starting the service.
- 2. Remove magnetic sill trim. (Figure 1)
- 3. Remove the 5 screws that secure the top grill (ULT40 3 screws). (Figure 2)
- Attach the suction cups to the front glass and use them to lift the glass up and tilt it to remove it. (Figure 3)
   Note: Set the front glass in a safe place for the duration of the service.

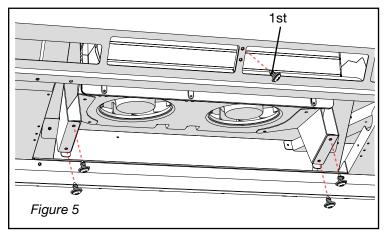
## **Heater Assembly Replacement**

- 1. Turn off the power to the fireplace from the electrical panel and follow steps for removing front glass.
- Remove the 4 screws on the middle service panel. Slide the plate back to release it. (Figure 4)
- 3. Disconnect the LEDs to remove the plate and set it aside.
- 4. Remove the 5 screws holding the defective heater, starting with the one on the front grill. (Figure 5)
- 5. Transfer the connections to the new heater assembly.
- 6. Secure the new heater assembly, starting with the one at the front on the grill.
- 7. Reinstall the middle panel assembly, starting from the back, ensuring that:
  a) the LED strip is reconnected at both ends
  b) the front of the service panel is tucked inside, sitting on top of the grill lip. (Figure 6)
- 8. Reassemble the fireplace.

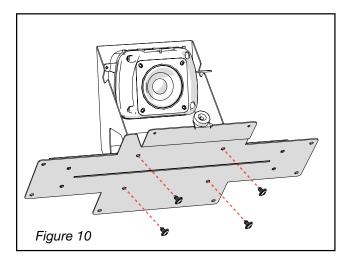
## Speaker replacement

- 1. Turn off the power to the fireplace from the electrical panel and follow steps for removing front glass.
- 2. Remove the 8 screws on the left service panel. Slide the bracket back to release it. (Figure 9)
- 3. Disconnect the LED connector for more maneuvering room (for ultra).
- 4. Remove the four screws that hold the speaker. (Figure 10)
- 5. Transfer the connector to the new speaker.
- 6. Secure the new speaker.
- 7. Reconnect the LED if removed.
- 8. Secure the bracket, ensuring the front part goes inside.
- 9. Reassemble the fireplace.

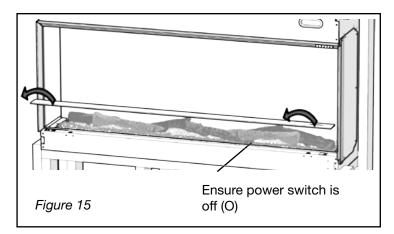
## Preparing the firebox for service under the media bed

Ember bed LED strips, power switch, and log expansion board are located under the ember bed.

- 2. Remove magnetic sill trim. (Figure 15)
- 3. Remove the 5 screws that secure the top grill (ULT40 3 screws). (Figure 16)
- Attach the suction cups to the front glass and use them to lift the glass up and tilt it to remove it. (Figure 17) Note: Set the front glass in a safe place for the duration of the service.

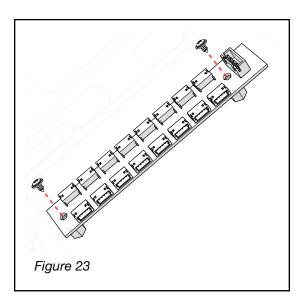
## **Expansion board replacement**

- 1. Turn off the power to the fireplace from the electrical panel and follow steps for servicing components under the ember bed.
- 2. Disconnect the 4 pin connector
- 3. remove the two screws
- 4. secure the new log expansion board
- 5. connect the 4 pin wires.
- 6. When reconnecting the logs, ensure they are connected sequentially, beginning with J1.
- 7. Reassemble the fireplace.

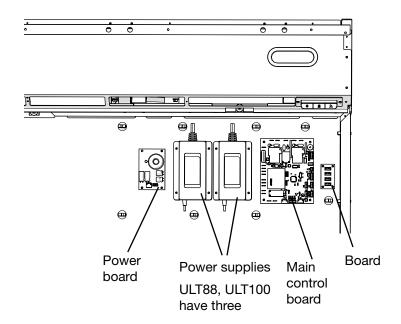
- 1. Turn off the power to the fireplace from the electrical panel and follow steps for service behind the mirrored glass.
- 2. Remove the eight (8) screws on the upper left service panel.

- 3. Slide the service panel back to release, and carefully lower it. Disconnect the LED connector and set the service panel aside.
- 4. Remove the two (2) screws on the temperature sensor bracket.

- 5. Cut the wire tie to remove the defective temperature sensor from its bracket.
- 6. Trace the temperature sensor wire to the main control board.
- 7. Disconnect the temperature sensor and remove it, cutting any restrictive wire ties.

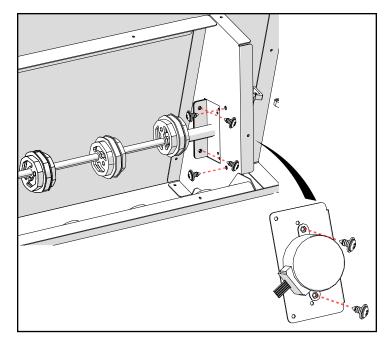
### Flicker motor replacement

- 1. Turn off the power to the fireplace from the electrical panel and follow steps for service behind the mirrored glass.
- Remove the flame panel.
   Note: On larger models there are multiple segments. Only the right side needs to be removed.
- Carefully pull the flicker rod off the flicker motor.
- 4. Remove the four screws on the flicker motor bracket.
- 5. Remove the two screws to remove the defective flicker motor and replace it with the new flicker motor.
- 6. Trace the wiring from the defective flicker motor to disconnect it and connect the new flicker motor in its place.
- 7. Use provided wire ties to bundle wires so that they are not obstructive, and they remain away from where the mirror will be (otherwise they will be visible during operation).
- 8. Secure the flicker motor bracket.
- 9. Reinstall the flame panel.
- 10. Reassemble the fireplace.
